Transforming Risk To Resilience in BESS

Green Tenaga PTE LTD

ASEAN Battery Safety & Innovation Conference 2025

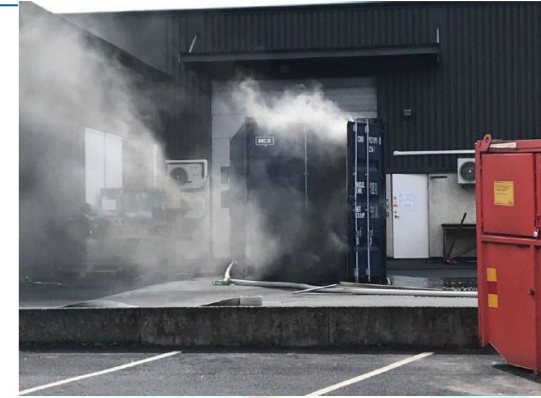
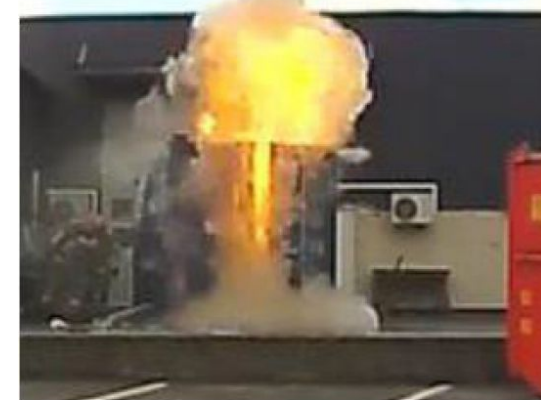
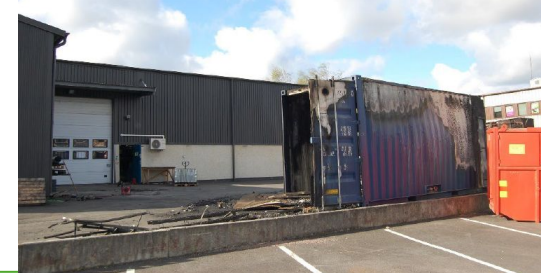
Gothenburg, Sweden

- 2023 – Fire & explosion at an 875kWh 20-foot battery container
- Unit was undergoing further integration works & prelim commissioning under shelter.

- Prelim analysis believes that during water pressure testing of the battery packs, some minor damage was done on the cells.
- White smoke was seen emitting out of the unit; leading first responders to close the container door & attempt to bring it to open spaces.
- While trying to bring the unit out, one of the trolley wheels disconnected, leading to more time wasted.
- It is believed that as the door was closed, the air mixture finally became deadly and sparked off the explosion.

- Mandatory pressure relief mechanisms (deflagration panel) in battery containers. If possible, emergency systems to be connected to 230VAC supply.
- Emergency BESS-specific fire training for responders.

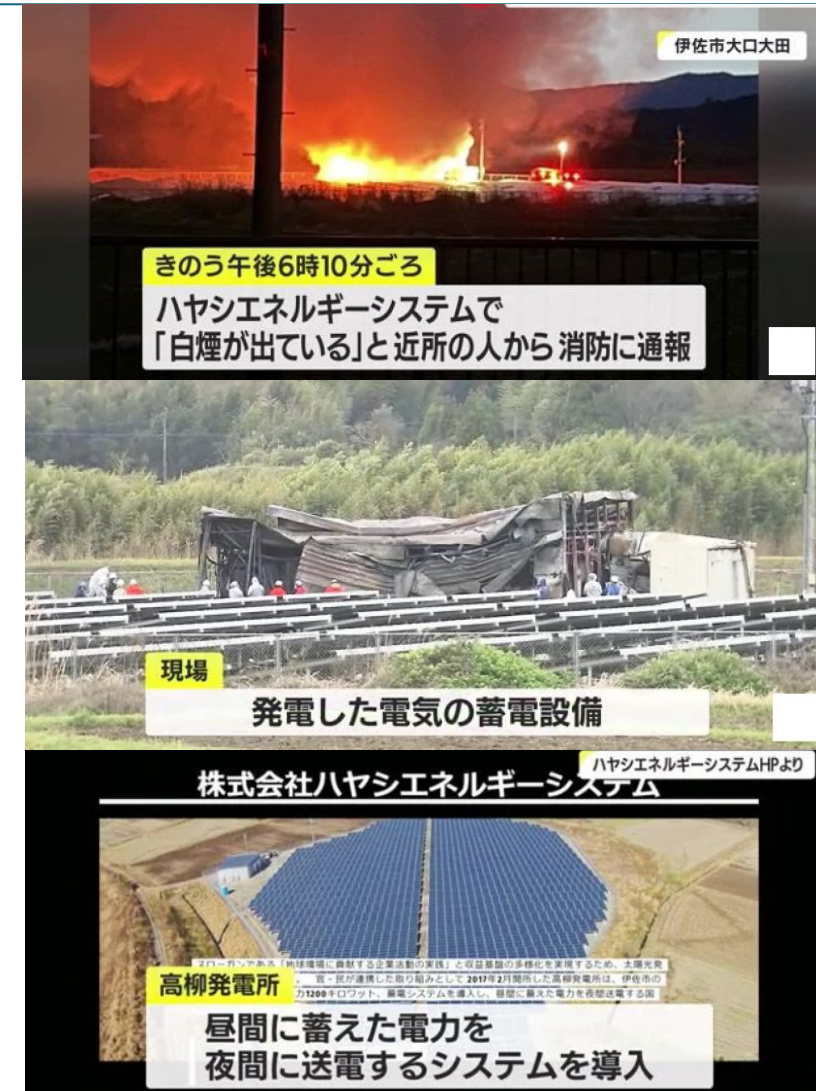
Isa City, Kagoshima, Japan

- 2024 – Fire and explosion in **BESS system co-located** with 1.2MWp solar plant.
- 4 firefighters injured due to the explosion.

- BESS housed in the building, air cooled type of cells started to emit smoke
- First responders saw it was filled with smoke & activated the building's exhaust system—an explosion occurred shortly after, collapsing the entire building.
- Fire extinguished 1.5 days later.

- Use of water cooled cells preferred, along with possibly putting it outdoors.
- Automated fire suppression systems for the BESS must match the building exhaust exchange/flow rate.
- Training programs for responders should include controlled explosion

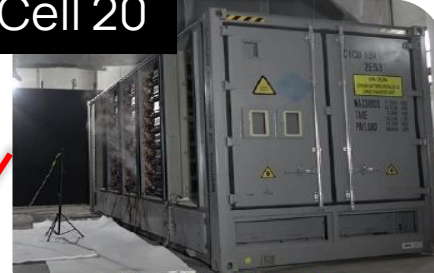
(d) Cell Thermal runaway
[00:59:45]

Cell 20

Initiating cell
(Cell 20)
Thermal
runaway trigger

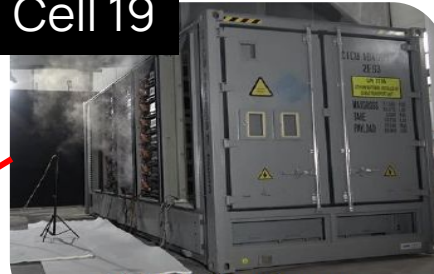
(e) Cell 19 Thermal runaway
[01:01:07]

Cell 19

Thermal
runaway **1 hour**
later at **Cell 19**

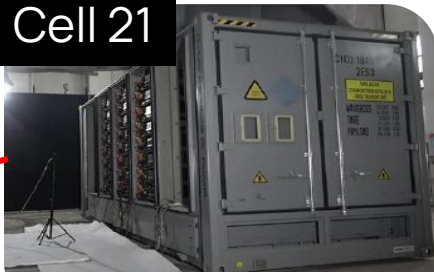
(f) Cell 21 Thermal runaway
[01:30:00]

Cell 21

Thermal
runaway 1.5
hours later at
Cell 21

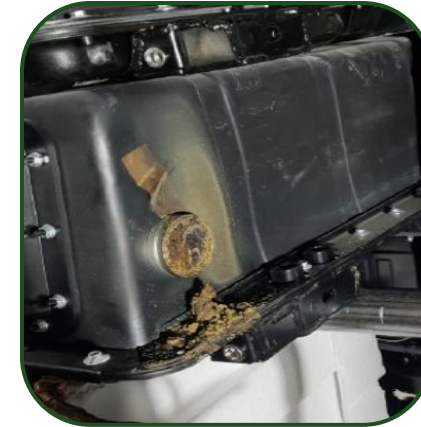
Cell 20: Module casing remains intact despite thermal runaway – signs of heat exposure, no burn-through, no fragmentation

No further smoke propagation observed in other adjacent battery packs

Minimal damage to all modules as seen above.
